OctArm Repair

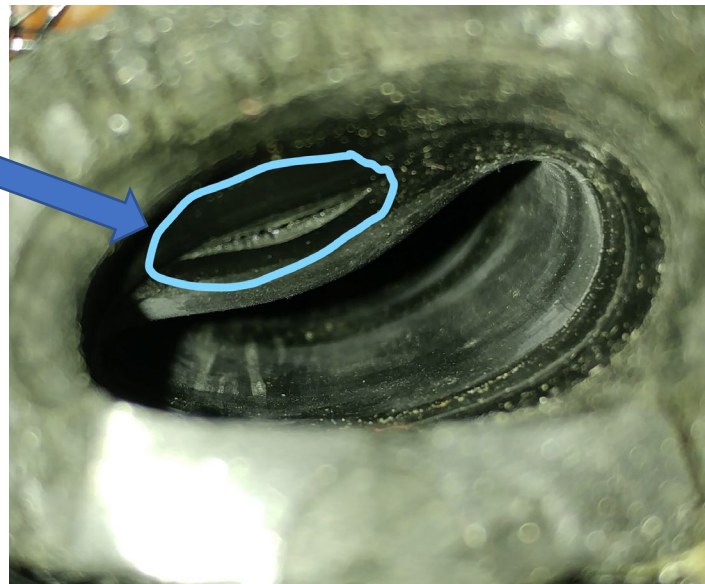
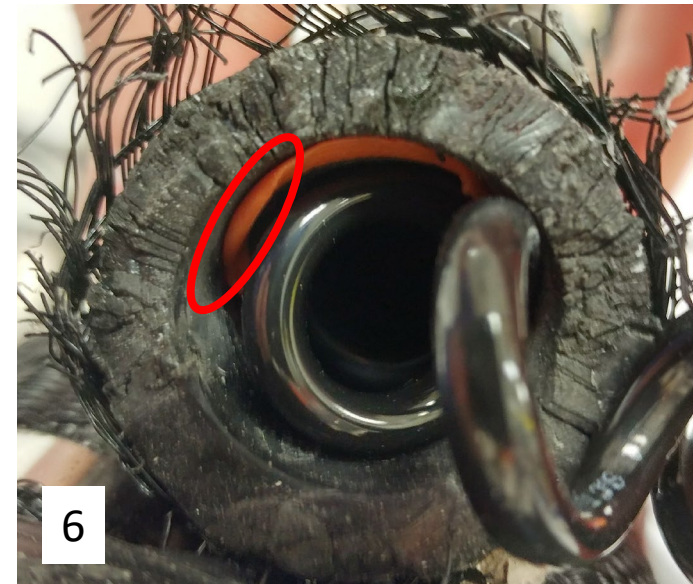
Found the leak!

- As expected, near barb edge of end cap

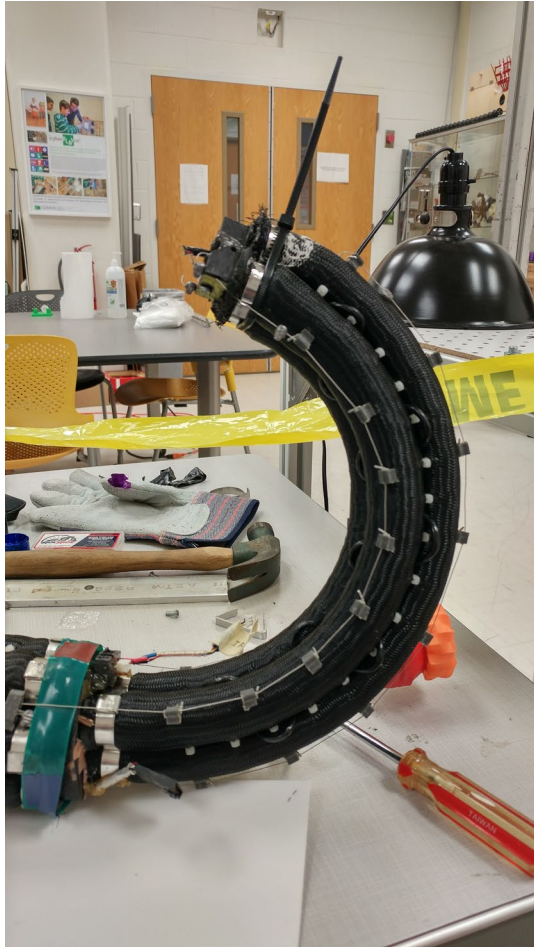
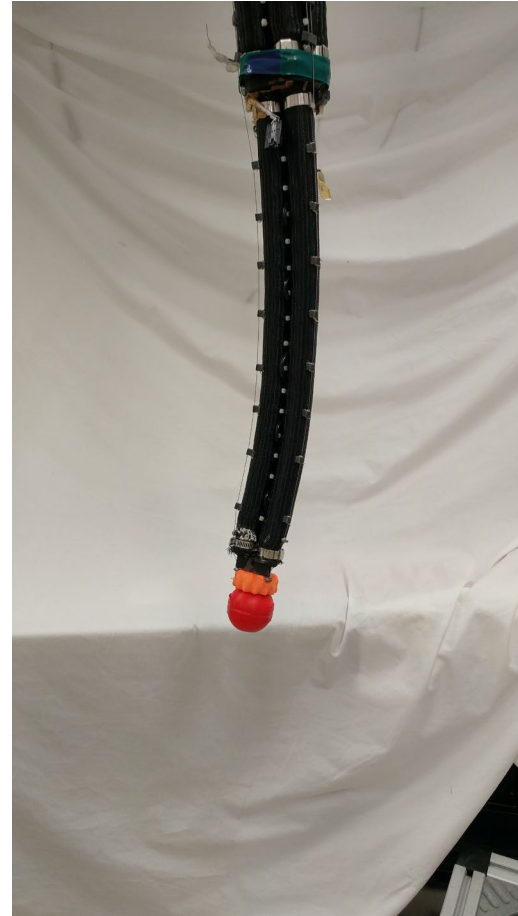
- Holds up to previous max pressure
- No audible leak
- Pressure retention equal to other muscles
