Electronic Systems Failures and Anomalies Attributed to Electromagnetic Interference

R.D. Leach and M.B. Alexander, Editor

National Aeronautics and Space Administration
Marshall Space Flight Center • MSFC, Alabama 35812

July 1995

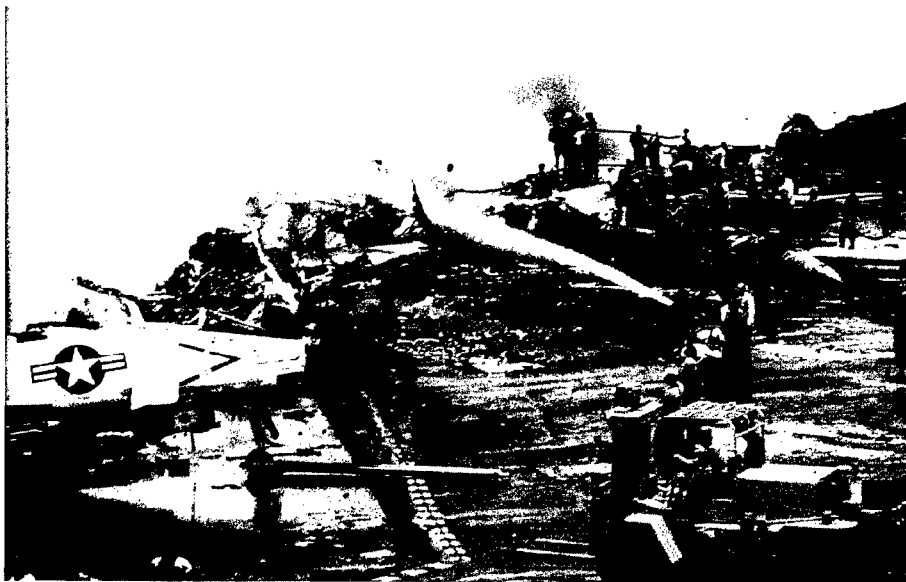
Figure 3. Aftermath of U.S.S. *Forrestal* EMI incident.

In 1967 off the coast of Vietnam, a Navy jet landing on the aircraft carrier U.S.S. *Forrestal* experienced the uncommanded release of munitions that struck a fully armed and fueled fighter on deck (fig. 3). The results were explosions, the deaths of 134 sailors, and severe damage to the carrier and aircraft. This accident was caused by the landing aircraft being illuminated by carrier-based radar, and the resulting EMI sent an unwanted signal to the weapons system. Investigations showed that degraded shield termination on the aircraft allowed the radar frequency to interfere with routine operations. As a result of this case, system level EMC requirements were revised to include special considerations for electroexplosive devices.¹²

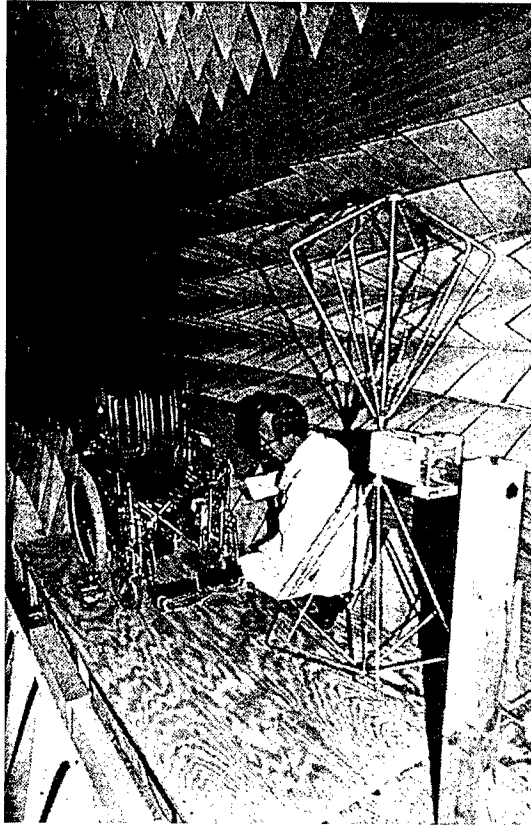
Figure 5. Testing a wheelchair for EMI.

Wheelchairs came under the scrutiny of the FDA (fig. 5) because of reported erratic, unintentional powered-wheelchair movements. These movements included sudden starts that caused wheelchairs to drive off curbs or piers when police, fire, or CB transmitters were activated near the chairs. Although no fatal injuries have been reported, FDA has ordered manufacturers of motorized wheelchairs to shield them from EMI and to educate users on the potential EMI hazards.²¹
