Unmanned Aircraft Systems (UAS) Impact on Operational Efficiency and Connectivity

Final Report

December 2019

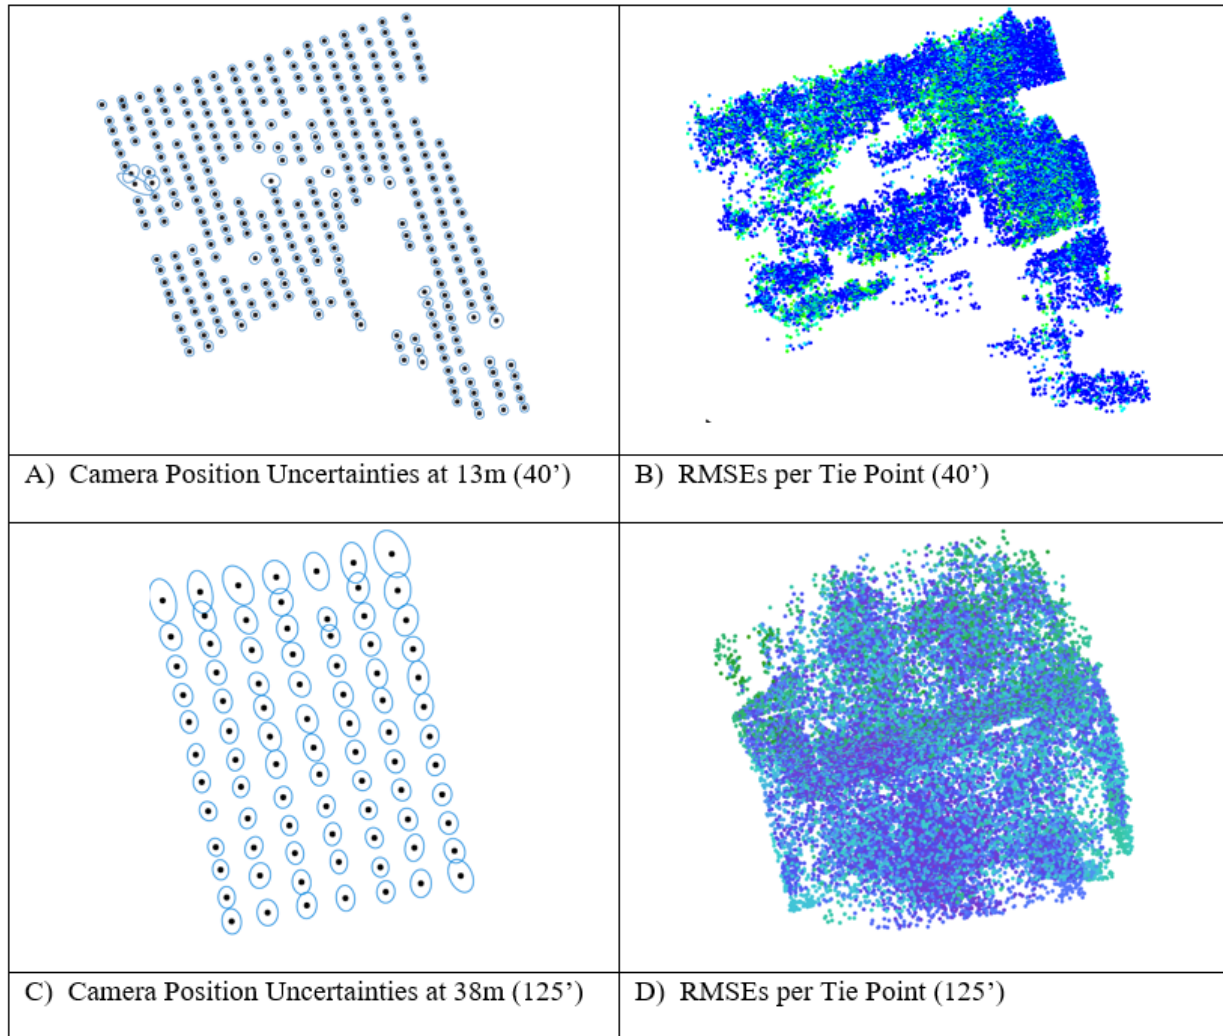
Figure 3.2: Data acquisition of P4P-A at 13m and 38m.

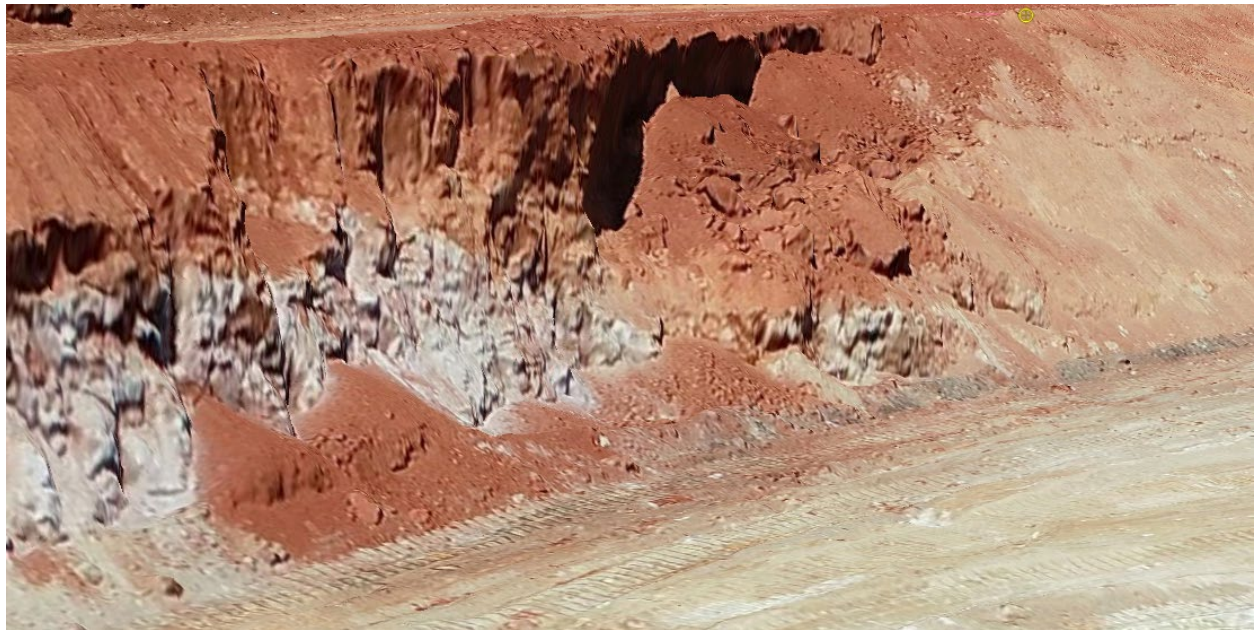
Figure 4.4: Embankment area of photometric survey.

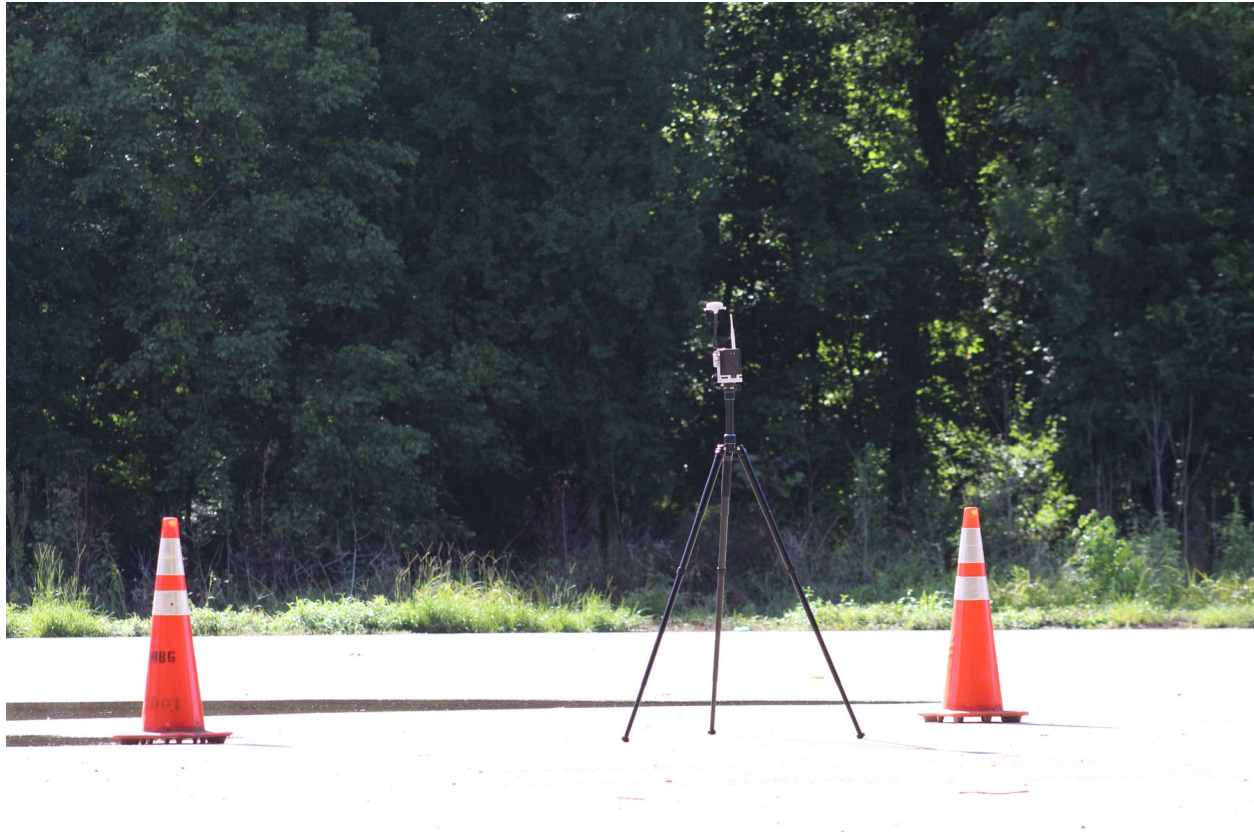
located on a tripod away from the bridge. The RTK unit located itself via satellite and then help position the M210 RTK drone when it flew in a GPS denied environment. TB50 and TB55 are two different battery types supported by the M210. (The second generation of the M210 is only supported by TB55 batteries.) TB50 is the smaller of the two and will sustain flight times of approximately 17 minutes when the Z30 is mounted. The TB50 was selected because, unlike the TB55, the manufacture sells a battery charging hub that can charge eight batteries at a time (figure 5.7). The research team found that a supply of 16 TB50 batteries was sufficient to continually charge batteries at the same rate they were depleted. Like most bridge sites, power was not available so a generator was procured. The charging station at full capacity drew 1,000W so a 2,000W generator was used to also support various other electronics like laptops, controller battery chargers, tablets and cell phones. This aircraft allows for the camera to be controlled by a second person with another controller. For this experiment, two Cendence controllers with 7.85-inch CrystalSky monitors were used (figure 5.8). The pilot controlled the aircraft while the BIE controlled the camera. The controller and monitor are both powered with a WB37 battery. The researchers found that four batteries in use, while another four were charging (eight total), were sufficient to keep the two controllers continually operational. Additional equipment and materials used included a 12'x12' tent, table, walkie-talkies, hard hats, safety vests, air horns, sunscreen, insect repellent, water/snacks, first aid kit, and safety cones (figure 5.9 and 5.10).

Figure 5.6: RTK ground station.

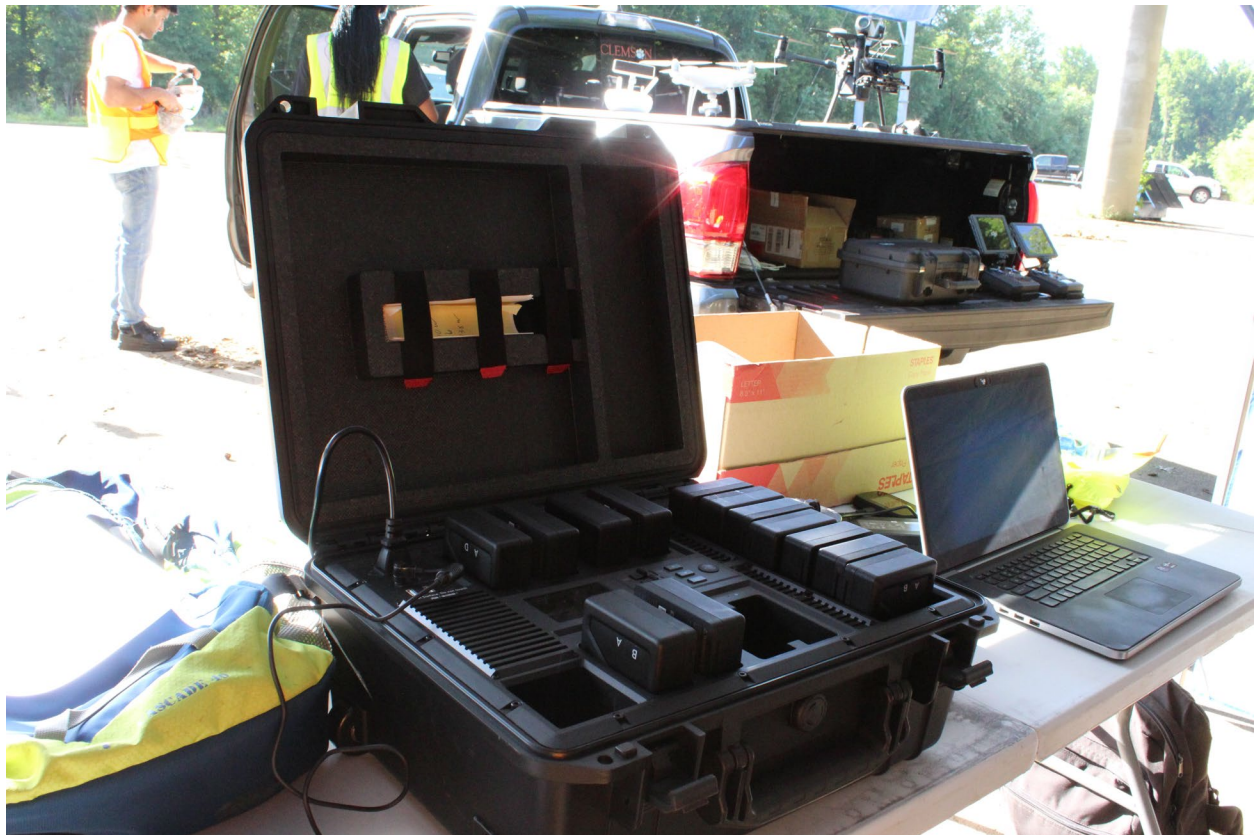
Figure 5.7: TB50 battery charging hub.

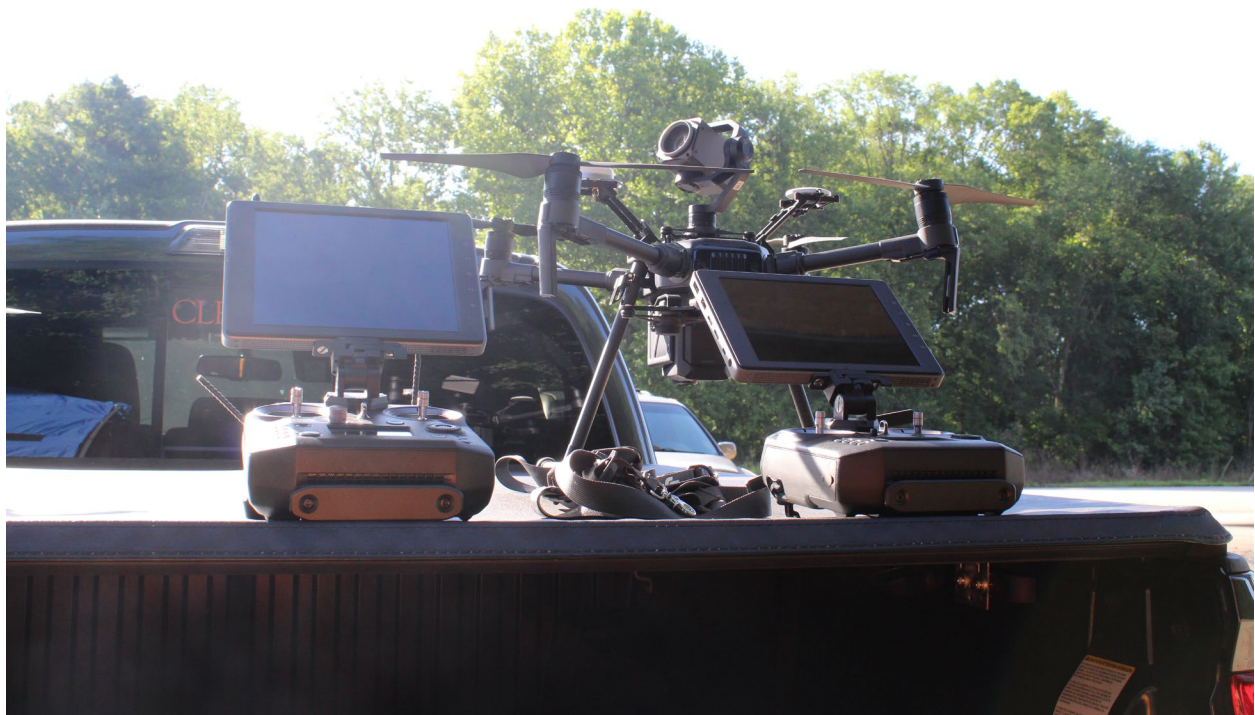
Figure 5.8: Cendence controllers with CrystalSky monitors.

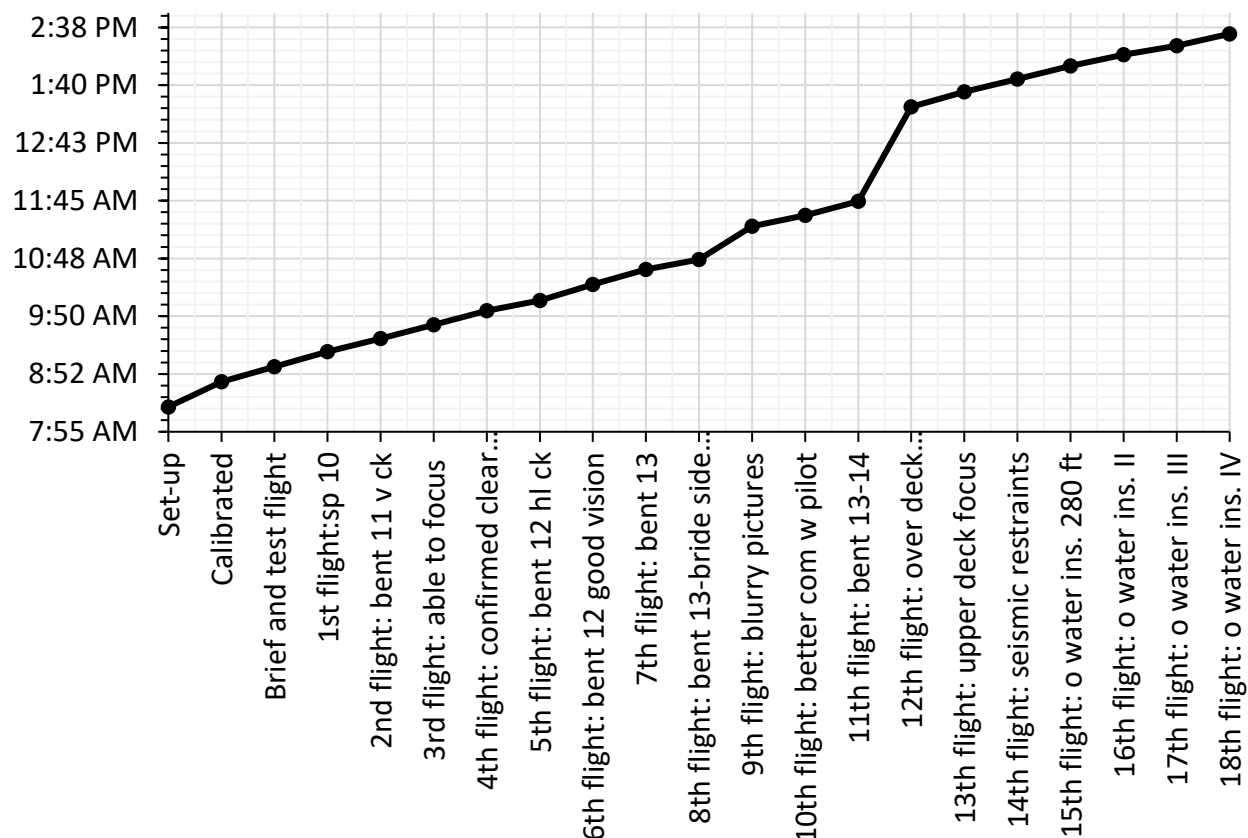
The first experiment was completed between 8:00 am and 3:00 pm on June 25th, 2019. Timestamps on the observations are attached in order to be able to gauge the length of the experiment, approach, and longitudinal information which are plotted in figure 5.19. Throughout the experiment, the crew pointed out either negative or positive aspects of the technology as a potential replacement to traditional methods.

Figure 5.19: Experiment #1 observation time stamp.

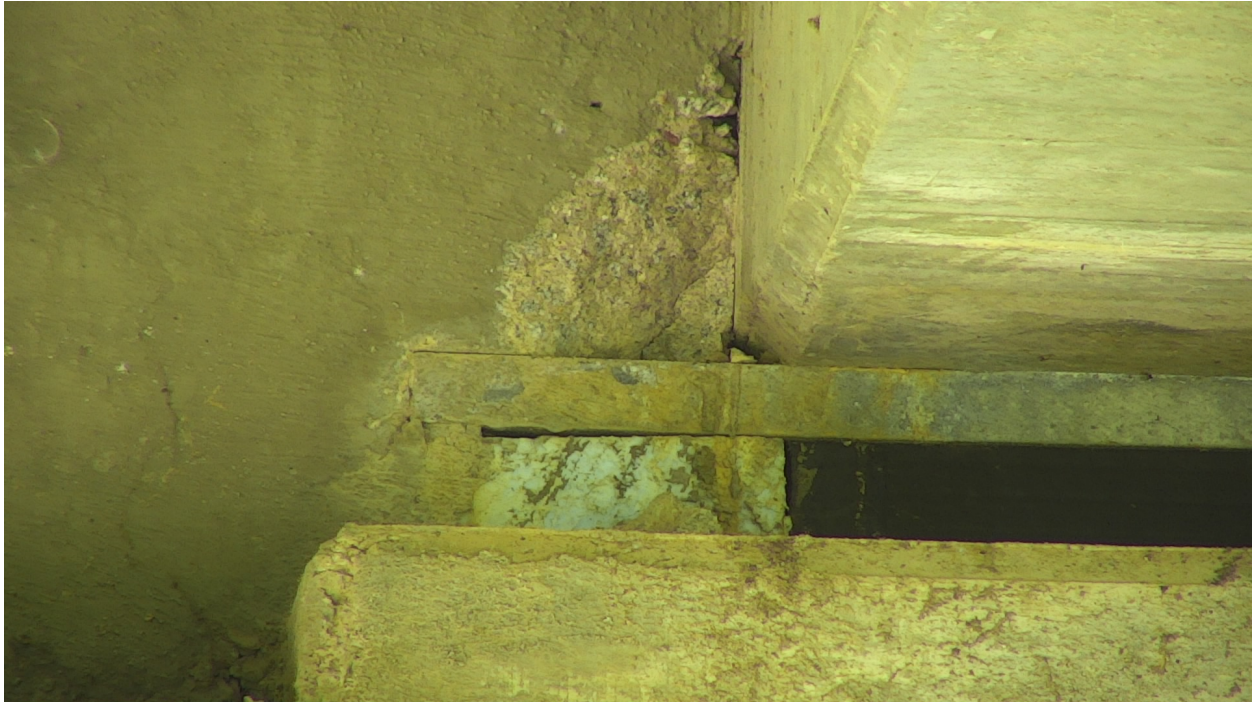
During the first flight, 9:00 am-9:15 am, inspection on the 10th span was carried out. Camera zoom was investigated. The most critically, bearings were checked. They were confirmed as too thin to see in detail and replied as “no” (figure 5.20 and 5.21). During this flight, zoom in, out, orientation with respect to beams, and the glare was figured out. At this stage, a significant amount of time was spent seeing the specific location of the previous crack noted. Both with checklist and drone piloting were coordinated successfully. Initially, it was asked if the pilot would be able to move up and down without being uncomfortable with the proximity of the structure. As the pilot’s and aircraft’s performance were improved, the BIE was later able to guide the pilot to specific spots with accurate distances. Moreover, a method was developed to scan through different sides of the bridge efficiently. This included mainly quickly finding good angles, zoom in and out, and to avoid sun glare. Note that the orientation initially was asked to pilot and a communication procedure with the pilot was demanded which later evolved to comfortable with orientation even if the aircraft was not seen. Except for one or two instances, the camera was very responsive,

Figure 5.20: Bearing unable to see sufficiently #1.

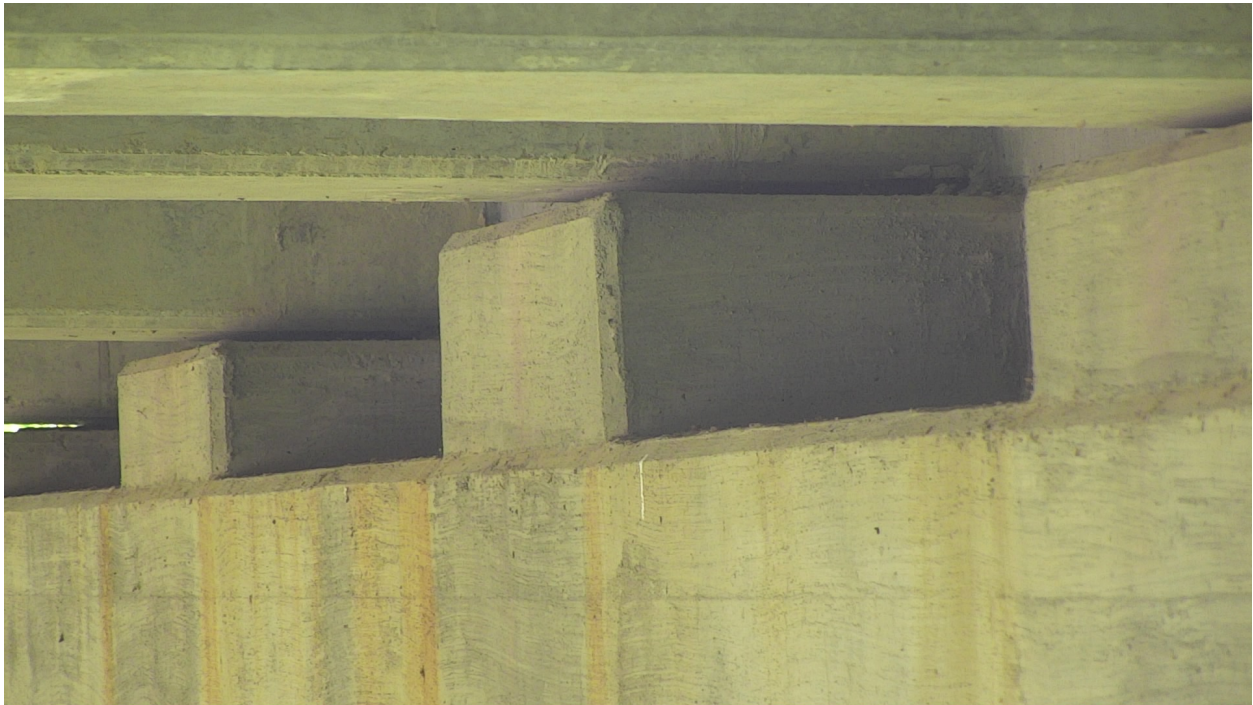
Figure 5.21: Bearing unable to see sufficiently #2.

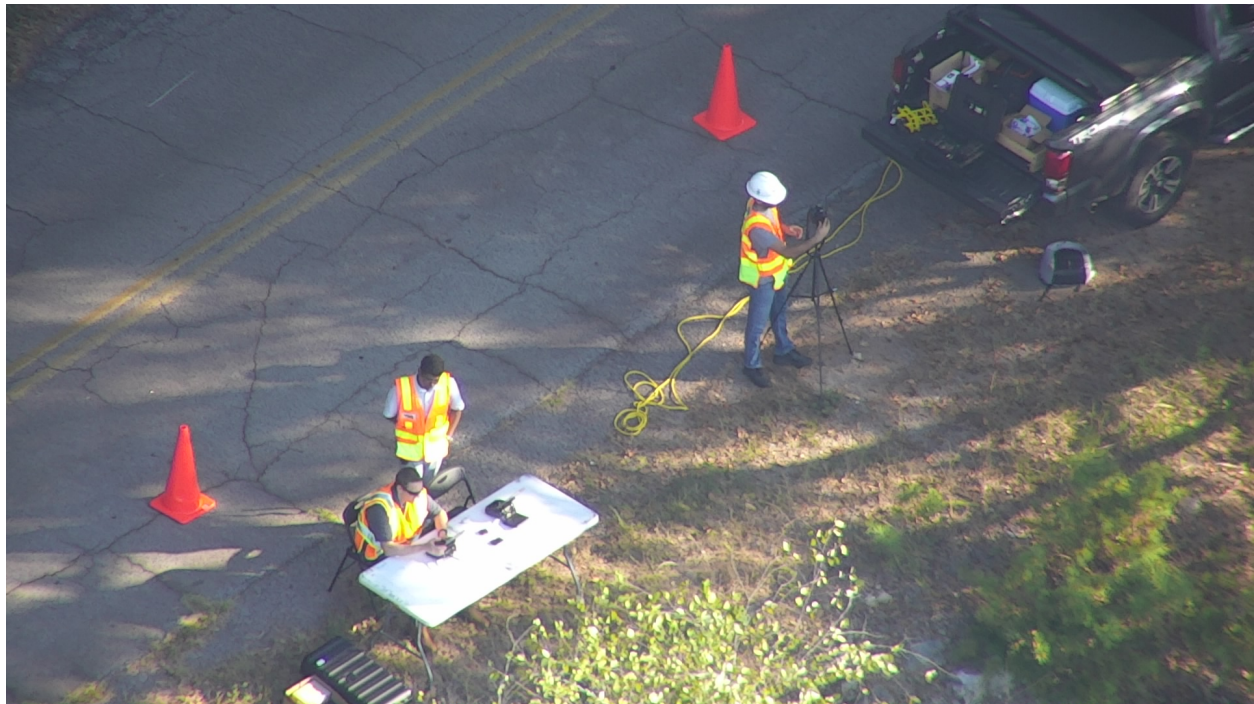
As a secondary experiment, the researchers conducted a proof of concept study of the possibility of inspecting a bridge with the BIE located off-site on October 2nd, 2019 (figure 5.26). The remote inspection experiment was very similar to the experiments previously described. The crew was made up of a pilot who commanded the aircraft, a co-pilot who controlled the camera and a third person who replaced batteries and managed the logistics of the site (figure 5.27). The BIE was

Figure 5.26: Remote BIE setup.
