TECHNICAL REPORT: CVEL-14-065

Electrical Behavior of Multi-Layer Ceramic Capacitors Damaged by Electrostatic Discharge

Dexin Zhang¹, Todd Hubing¹, Andrew Ritter² and Kiran Patil¹

October 6, 2014

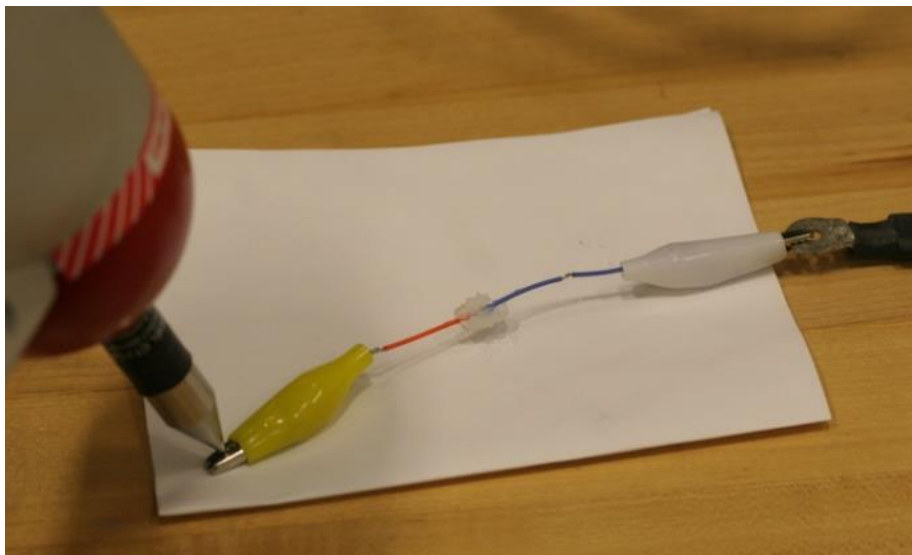
A human body model ESD stress was applied to MLC capacitors using a 150 pF/330 Ω ESD simulator configured as shown in Fig. 1. A contact discharge was used to minimize the variation of energy passing through the capacitor from one test to another. The capacitors were covered with silicone gel to avoid an air or surface discharge between the terminals of the capacitor. MLC capacitors with rated values of 1 nF, 10 nF and 100 nF were obtained from three manufacturers. All capacitors in this study were Type II X7R capacitors with 0603 packages and 50-V ratings. Tests were conducted on 8 samples of 1-nF and 10-nF capacitors and 3 samples of 100-nF capacitors.

Fig. 1. ESD test setup with the capacitor under test covered with silicone gel.

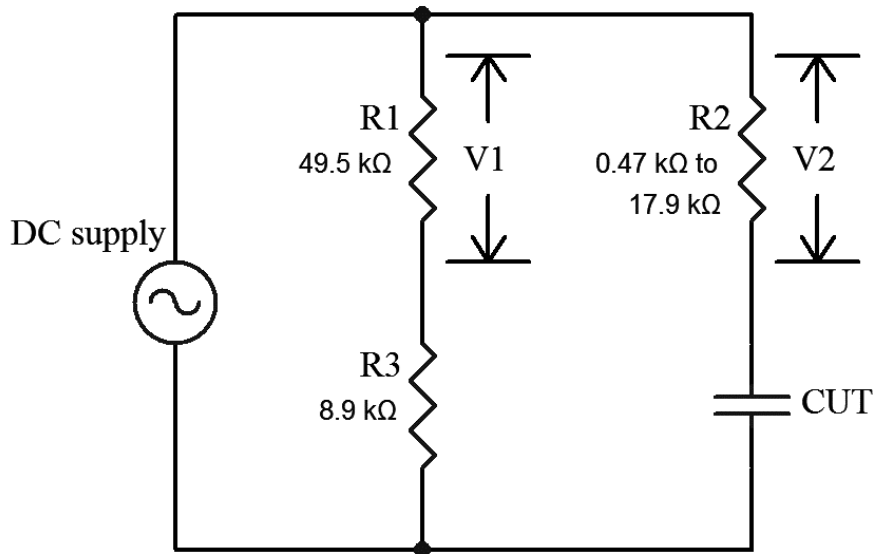
After each test, the DC resistance of the capacitor was measured using an LCR meter. The capacitor was considered to be damaged if the measured resistance was less than 10 M Ω . If it was not damaged, the test was continued at the next voltage level, and this was repeated until the capacitor was damaged. For example, on a 1-nF capacitor, the test was started at 2 kV and incremented in steps of 1 kV until reaching the observed failure voltage level, which ranged from 4 kV to 7 kV. Defective capacitors were connected to a voltage divider circuit as shown in Fig. 2. An applied DC voltage was varied from 0 to +60 V while measuring the voltage across and current through the capacitor to obtain the I-V curve. The capacitor was tested in both polarities, with the applied voltage magnitude represented by the waveform in Fig. 3. The current flow through the sample determined from the voltage across R2. The voltage was calculated from V1 and V2.

Fig. 2. Test circuit for evaluating degraded capacitors.

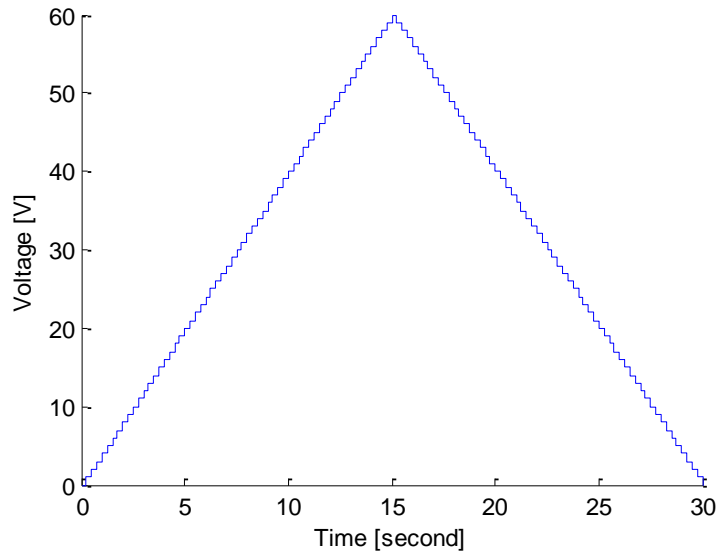
Fig. 3. Applied test waveform from the DC supply.

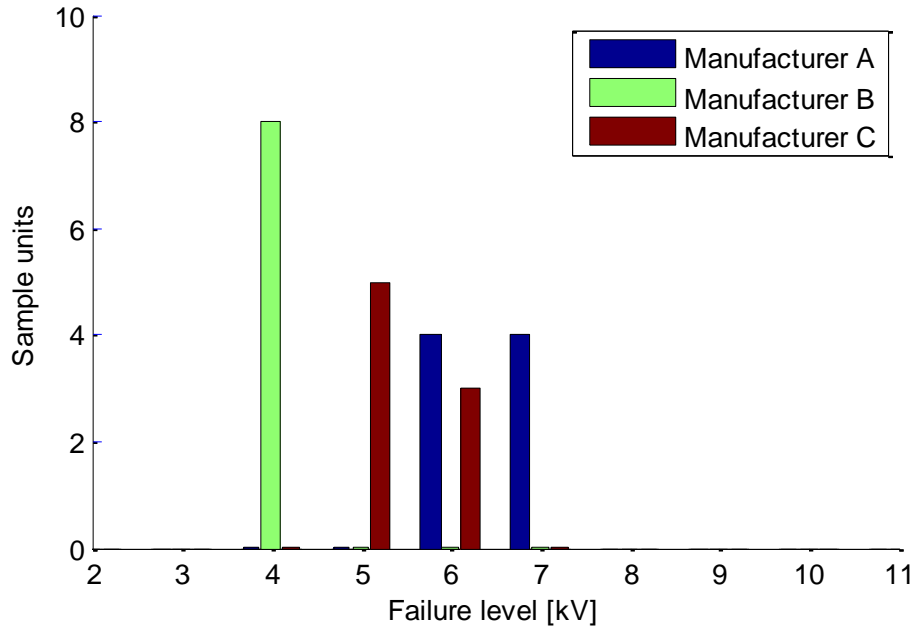
The failure voltage levels corresponding to ESD tests on capacitors with 1-nF and 10-nF rated values from different manufacturers are shown in Fig. 4 and Fig. 5, respectively. The results indicate consistent failure levels of 4 kV and 15 kV for 1 nF and 10 nF capacitors, respectively, from manufacturer B. For manufacturers A and C, there was some variation in the failure levels. None of the 100-nF capacitors tested were damaged at any level. All of them withstood the maximum 30-kV discharge.

Fig. 4. Histogram of contact ESD failure voltage levels on 1-nF capacitors.

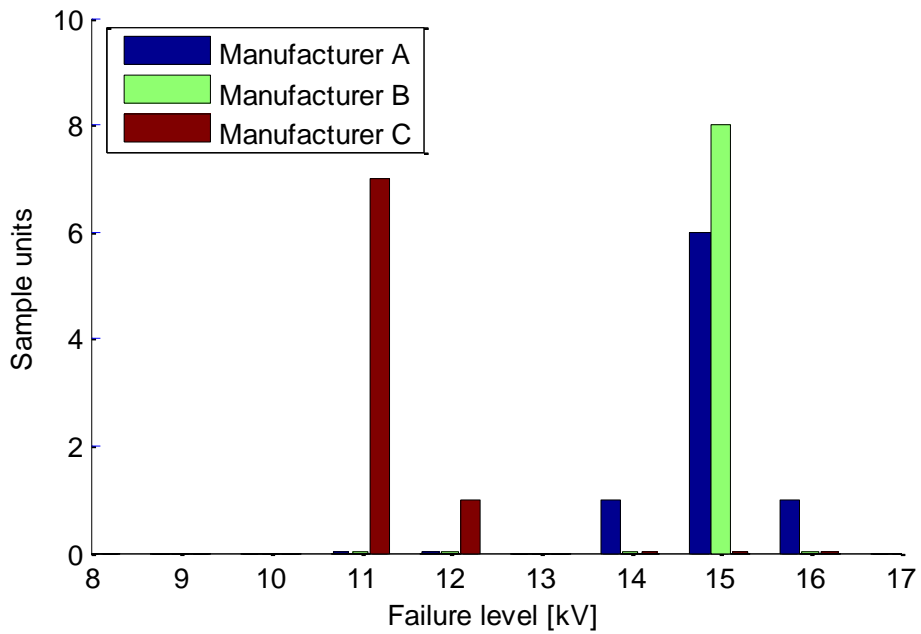
Fig. 5. Histogram of contact ESD failure voltage levels on 10-nF capacitors.

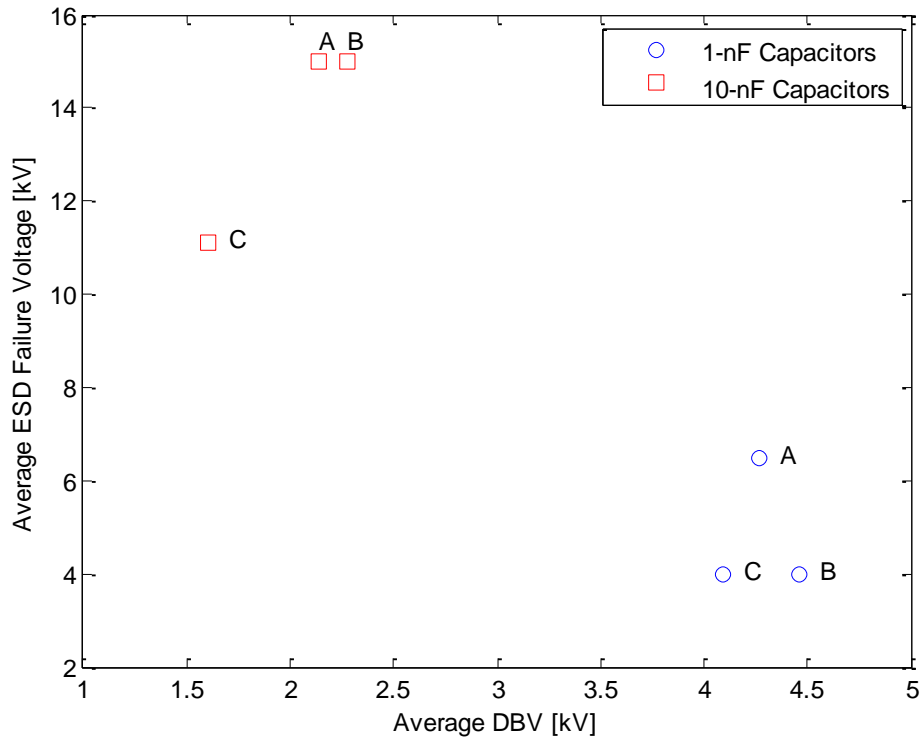
Eight capacitors of each type from the same lots were tested to determine their dielectric breakdown voltage (DBV) using a slowly ramping applied voltage. The results are summarized in Fig. 6. 1-nF capacitors had higher DBVs but failed at lower ESD voltage levels than 10-nF capacitors. This is likely due to the fact that a 10-nF capacitor is able to hold more charge at a given voltage level. Thus with the same level of charge injection, the maximum voltage across a test capacitor during an ESD event is lower for larger-valued capacitors. As indicated in Fig. 6, there didn't appear to be any correlation between the DBV and the ESD failure level for capacitors of the same nominal value.

Fig. 6. Comparison between average ESD failure levels and average DBVs.

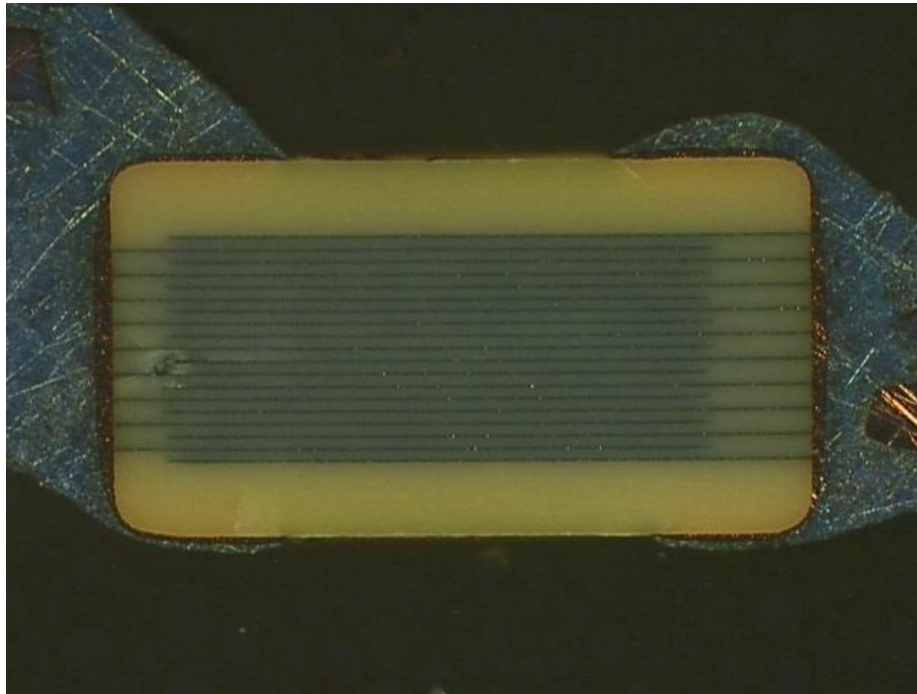
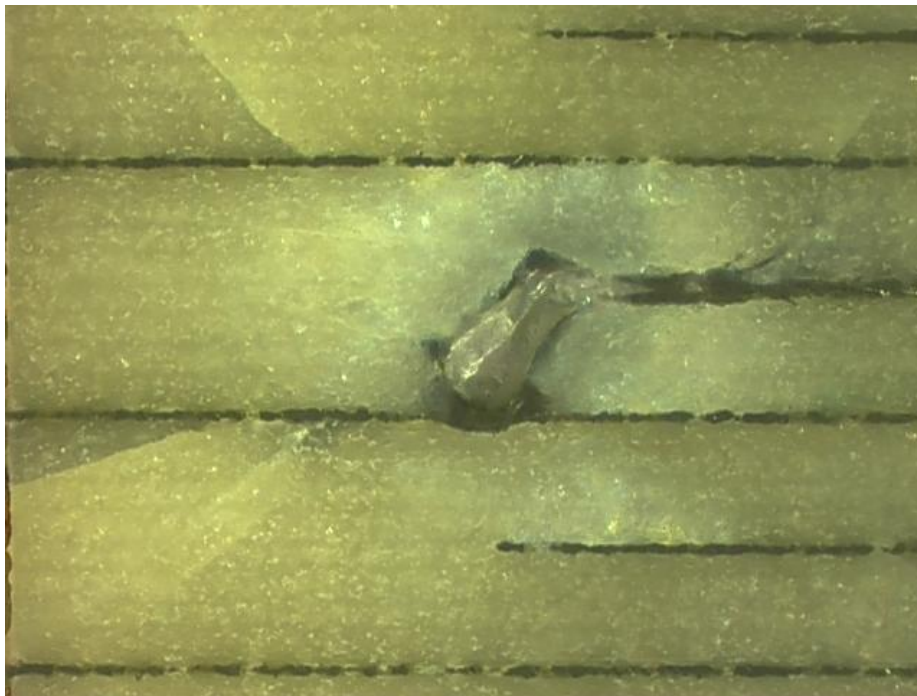
Three 10-nF capacitors from manufacturer A that had failed after being exposed to ESD transients were sent for a destructive physical analysis. The analysis involved grinding and polishing sections of these ceramic capacitors in order to identify possible defects in their structure. As indicated in Fig. 7, failed capacitors exhibited cracks in the dielectric at the edges of one or more internal electrodes. The locations of the failure sites indicate weak points in the capacitor in terms of electrical and mechanical stress during an ESD strike. This is in line with a simulation result in [13] that demonstrates that the ends of the internal electrodes exhibit the highest electric field density and mechanical stress under applied transient voltages.

(b) With a 50x amplification.

(b) With a 500x amplification.

Fig. 7. Site of an ESD failure in a 10-nF capacitor.

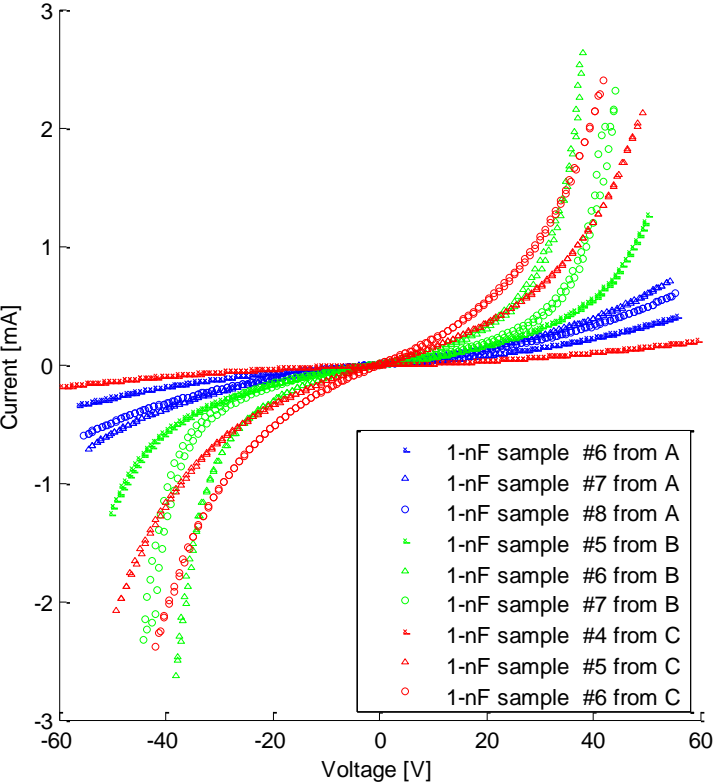
The I-V characteristics of damaged 1-nF and 10-nF capacitors are shown in Fig. 8 and Fig. 9, respectively. In these figures, a non-linear resistance between the capacitor terminals is observed. The plots are highly symmetric as demonstrated by Fig. 10, which overlays plots of the current due to the forward and reverse voltages for two sample capacitors. Comparing Fig. 8 and Fig. 9, it is also worth

Fig. 8. I-V characteristics of 1-nF defective capacitors.

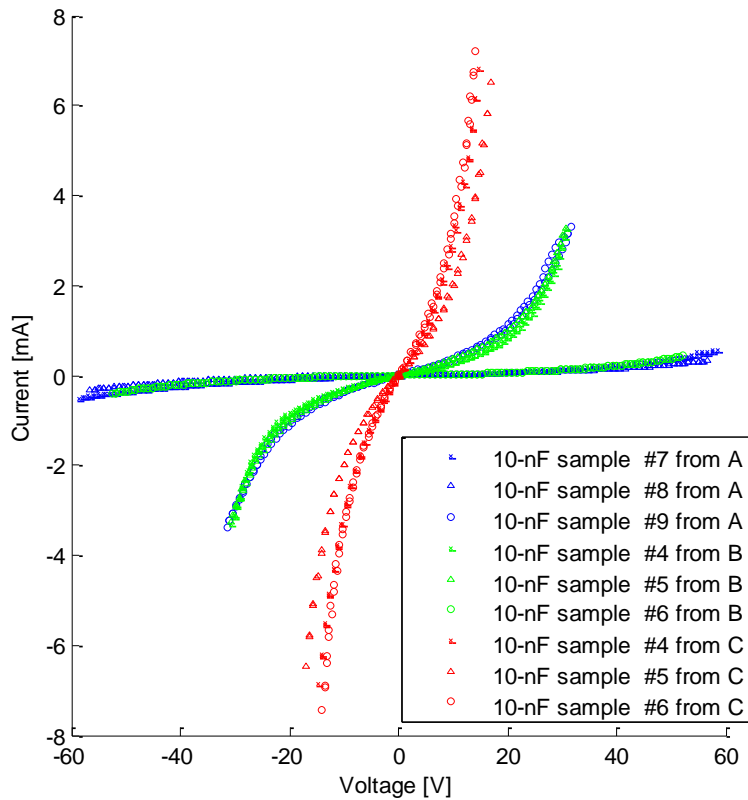
noting that the 10-nF capacitors from different manufacturers exhibited very different behavior, but the behavior was consistent for capacitors from any given manufacturer.

Fig. 9. I-V characteristics of 10-nF defective capacitors.

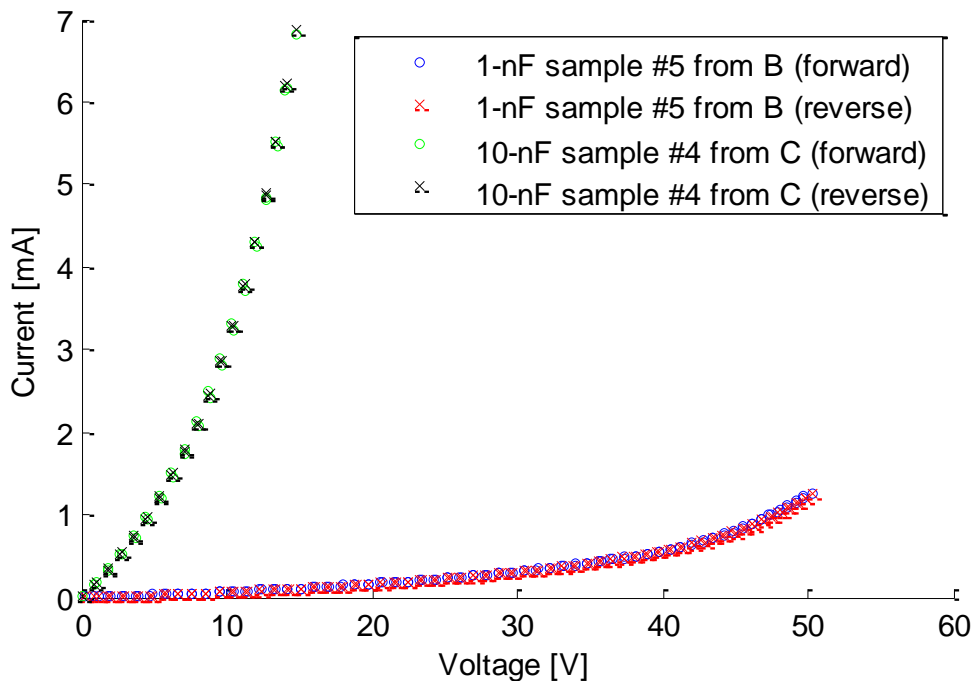
Fig. 10. Symmetric characteristics of the I-V curves.

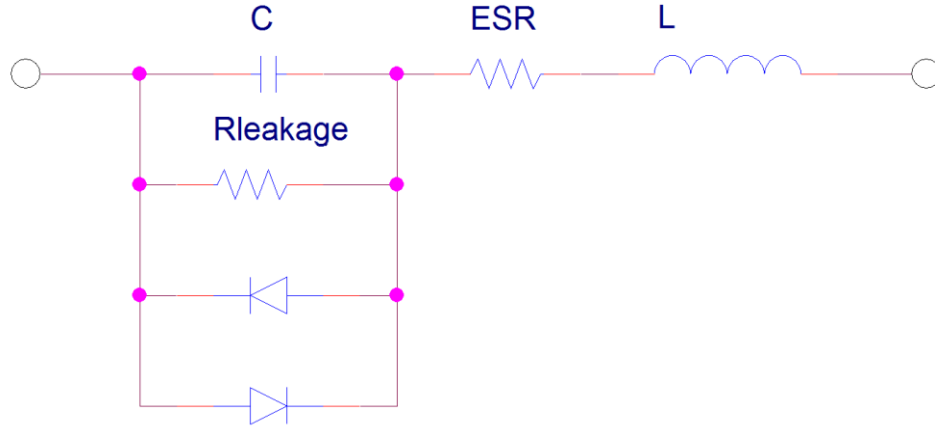
Considering the exponential increase in current with the increase in applied DC voltage, the behavior of the degraded capacitors can be modeled with a pair of diodes as shown in Fig. 11.

Fig. 11. Equivalent circuit of a degraded capacitor.

At very low frequencies, the connection inductance (L) and equivalent series resistance (ESR) are neglected. A large-valued shunt resistor ($R_{leakage}$) is used to model the initial leakage current (before the capacitor fails). In the degraded capacitor, this resistance can be neglected because the current flowing through the diodes in the model of the degraded capacitor is much higher than the leakage current represented by $R_{leakage}$. The I-V characteristics of the failed capacitors can then be modeled with two identical diodes. The relationship between the current and the voltage across these diodes can be written as,

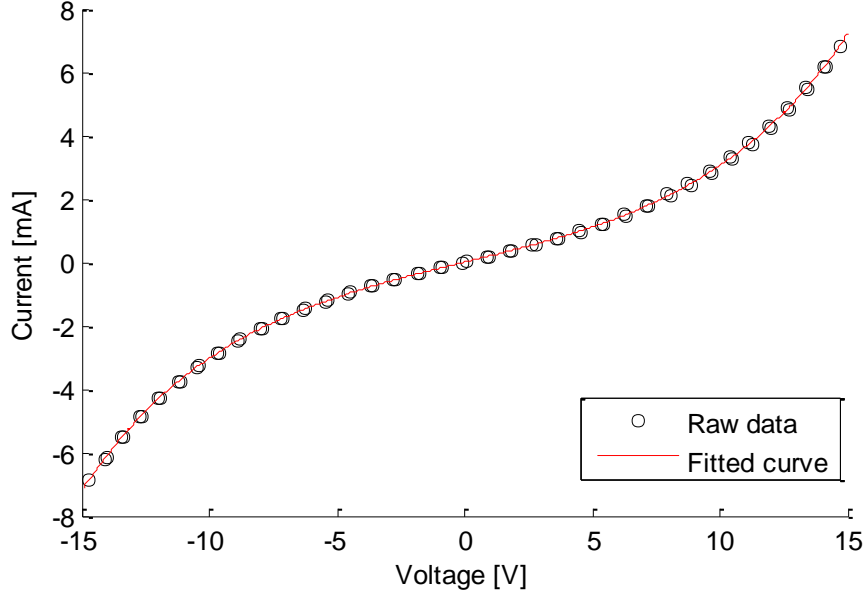
Fig. 12. Curve fit of I-V characteristics for the 10-nF sample capacitor #4.

The coefficients, I_S and R_{0V} , in the proposed model were derived for the degraded capacitors in this study. Assuming room temperature, the emission coefficient was obtained using Equation (3). The values obtained for the 1-nF and 10-nF capacitors from each manufacturer are provided in Table 2 and Table 3, respectively. Fig. 12, which shows the I-V characteristics of the 10-nF sample #4 from manufacturer C, shows that the model does a good job of fitting the measured data. The root-mean-square error (RMSE), defined as the square root of the mean square difference between the modeled and measured values, is also listed in the tables. The low values of RMSE indicate good fits of the model with the measurements. From the data in Table 2 and Table 3, it can be observed that, 10-nF capacitors are more likely to have low fault resistances at a small bias voltage than 1-nF capacitors.
