OctArm Repair

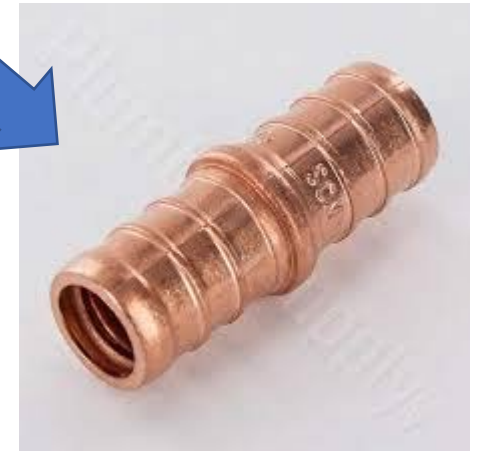
- Holds up to previous max pressure
- No audible leak
- Pressure retention equal to other muscles

- Use different end caps
 - Avoid barbs if possible – sand down if not
 - Use crimp/clamp expansion connections
